# **Monitoring and Assessing the Long-term Environmental and Use Impacts on Selected Mountain Bike Trails in South Australia**

**prepared for  
Mountain Bike Australia**

**by  
Stuart Clement Solutions  
Adelaide  
South Australia**

18 May 2010

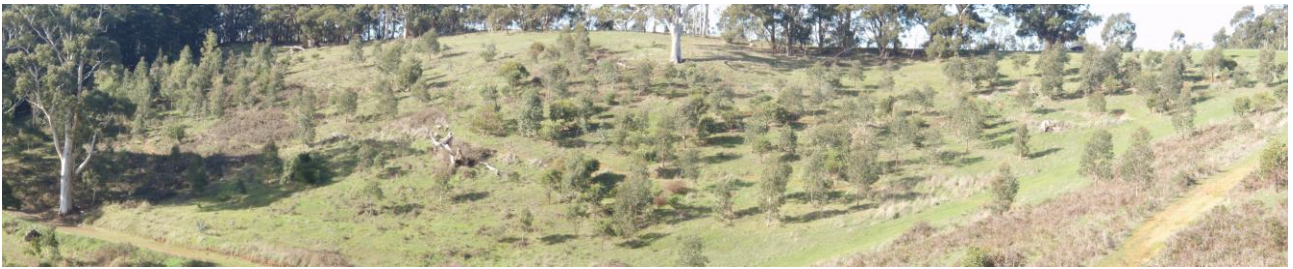
**Figure 1** Panorama of part of *Dynamic Tension* (June 2009). This section of trail (running roughly horizontally across the middle of the photograph) contains transect points 1 to 15

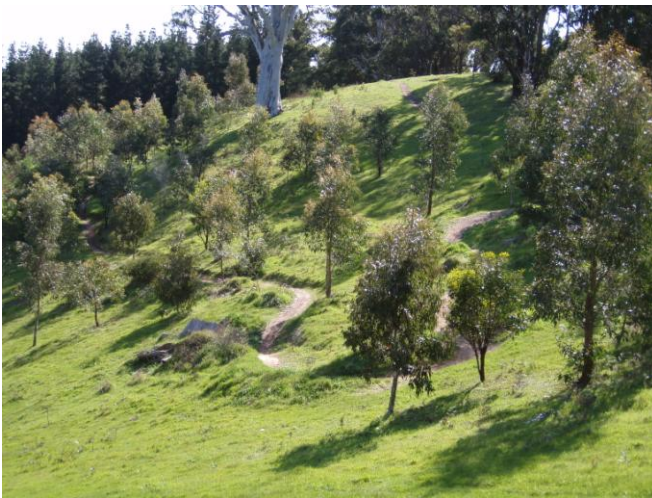
**Figure 2** View of transect points 3 to 5 of *Dynamic Tension* (September 2009)

particular gum trees – in the few years since the trail was commissioned in 2005 (see Figure 1 and Figure 2).

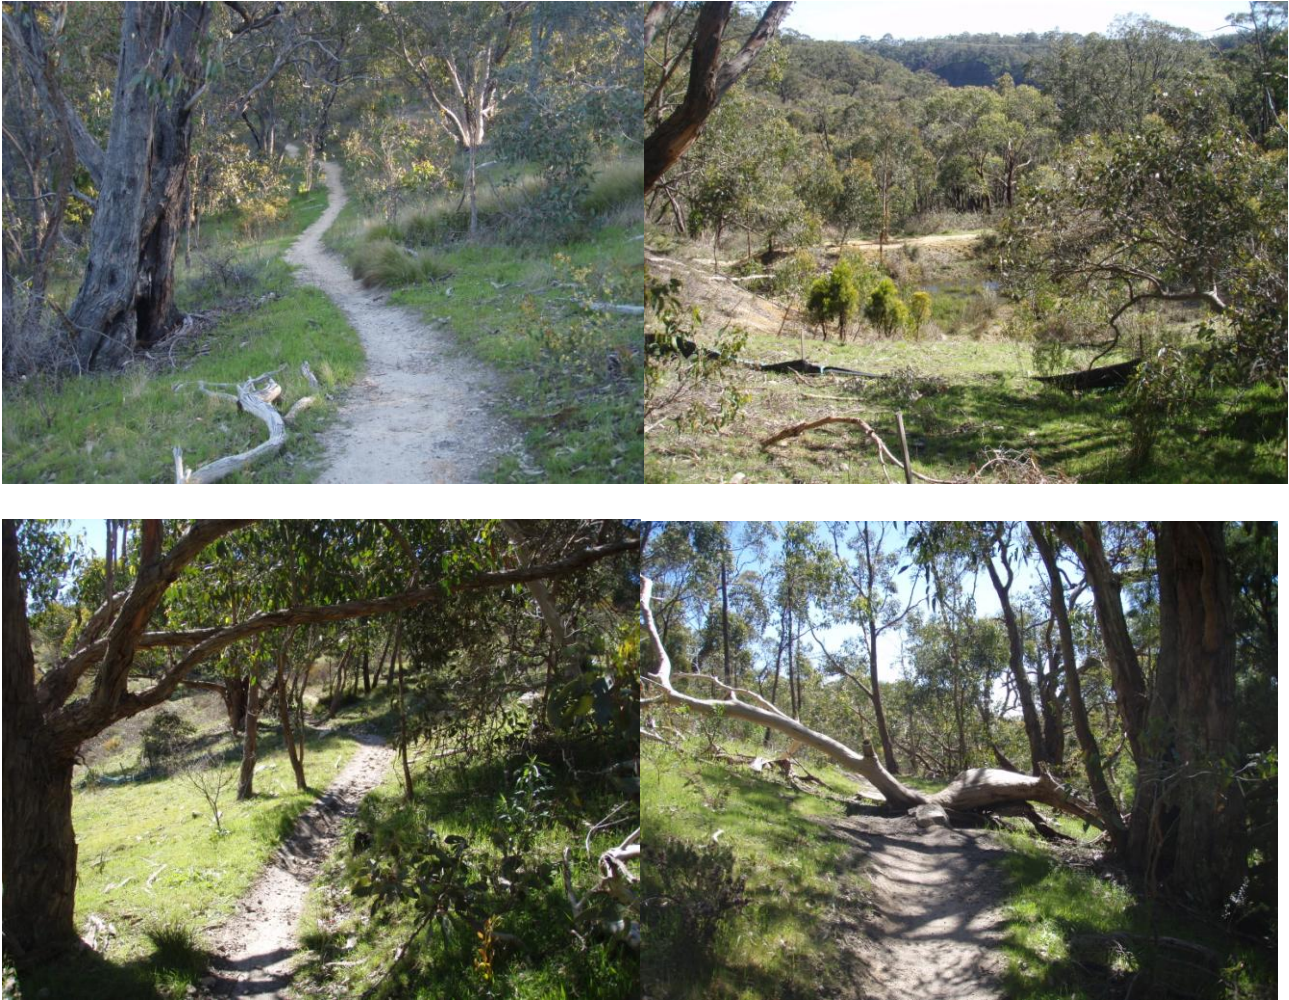
**Figure 3** Views of *Tunnel Vision*. Clockwise from top left: from the nominal start of the study section (September 2008); the trail on the dam wall between transect points 8 and 9 (September 2009); tree obstacle between transect points 16 and 17 (September 2009); and looking back from transect point 13 (September 2009).

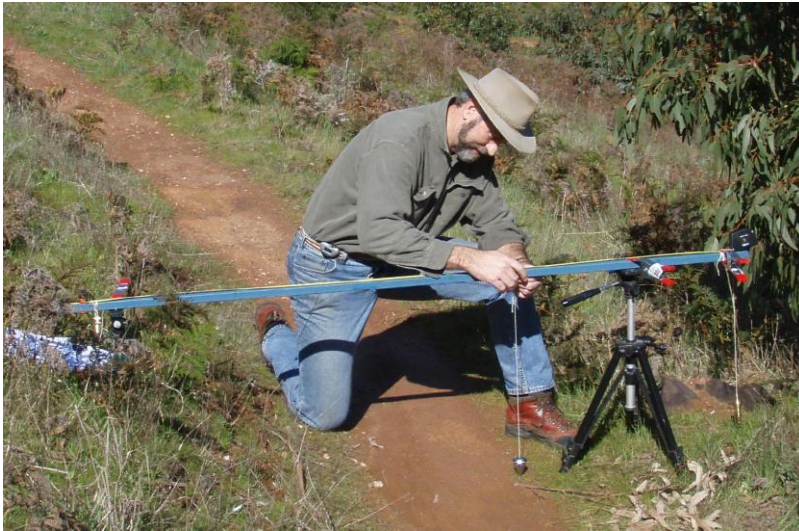
**Figure 4** Transect profile measurement setup

A transect profile (cross-section of the trail) is found by measuring the vertical distance from a horizontal straight edge to the trail surface at several measuring points along the trail transect (Figure 4). The transect is the plan view line between two reference pegs: the upside reference peg (URP) and its downside counterpart (DRP) placed each side of the trail. The straight edge is mounted on tripods and positioned so that the edge of the beam from which the measurements are taken is directly above the holes drilled into the middle of the top surface of each of the reference pegs. Accuracy is achieved using plumb bobs dropped from the straight edge to the pegs. Similarly, the vertical distance from the straight edge to the trail surface is found by dropping a plumb bob to the trail surface. A flat, steel tape measure is clamped to the top of the beam, and positioned so that the horizontal distance of each measuring point from the upside reference peg is recorded. A view of the apparatus setup is shown in Figure 4.

The extent of the measurement is governed by what is adjudged to be the used tread width. The used tread width is bounded by the Upside Tread Boundary (UTB) and the Downside Tread Boundary (DTB). The used tread is defined as that part of the full tread that is used by at least 95 per cent of riders. The UTB and DTB are adjudged in the first (baseline) survey and are two of the reference points at which measurements are taken during each survey. If, during a subsequent survey, the used tread width is adjudged to have changed, then the new used tread boundaries are labelled UTB' and DTB'. Measurements are taken at these new boundaries **and** at the original UTB and DTB to enable a comparison of the transect profiles.

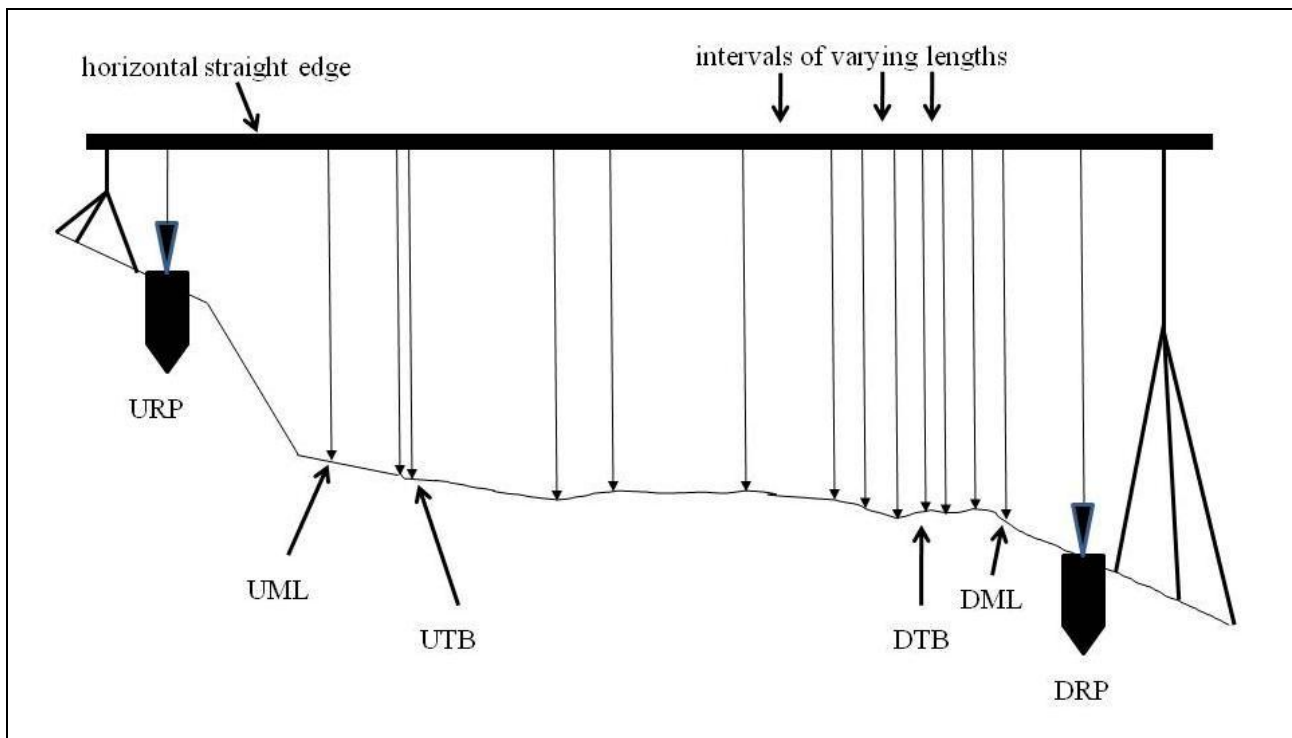
Figure 5 shows a representation of a trail profile with the natural line of the hillside to the extreme left and right of the diagram. The horizontal straight edge is supported by tripods. The plumb bobs are shown over the reference pegs URP and DRP. The used tread width boundaries are indicated with UTB and DTB and the full measuring width boundaries 20cm each side of the used tread width are indicated with UML and DML.

**Figure 5 Diagram of the variable interval cross-sectional area method**

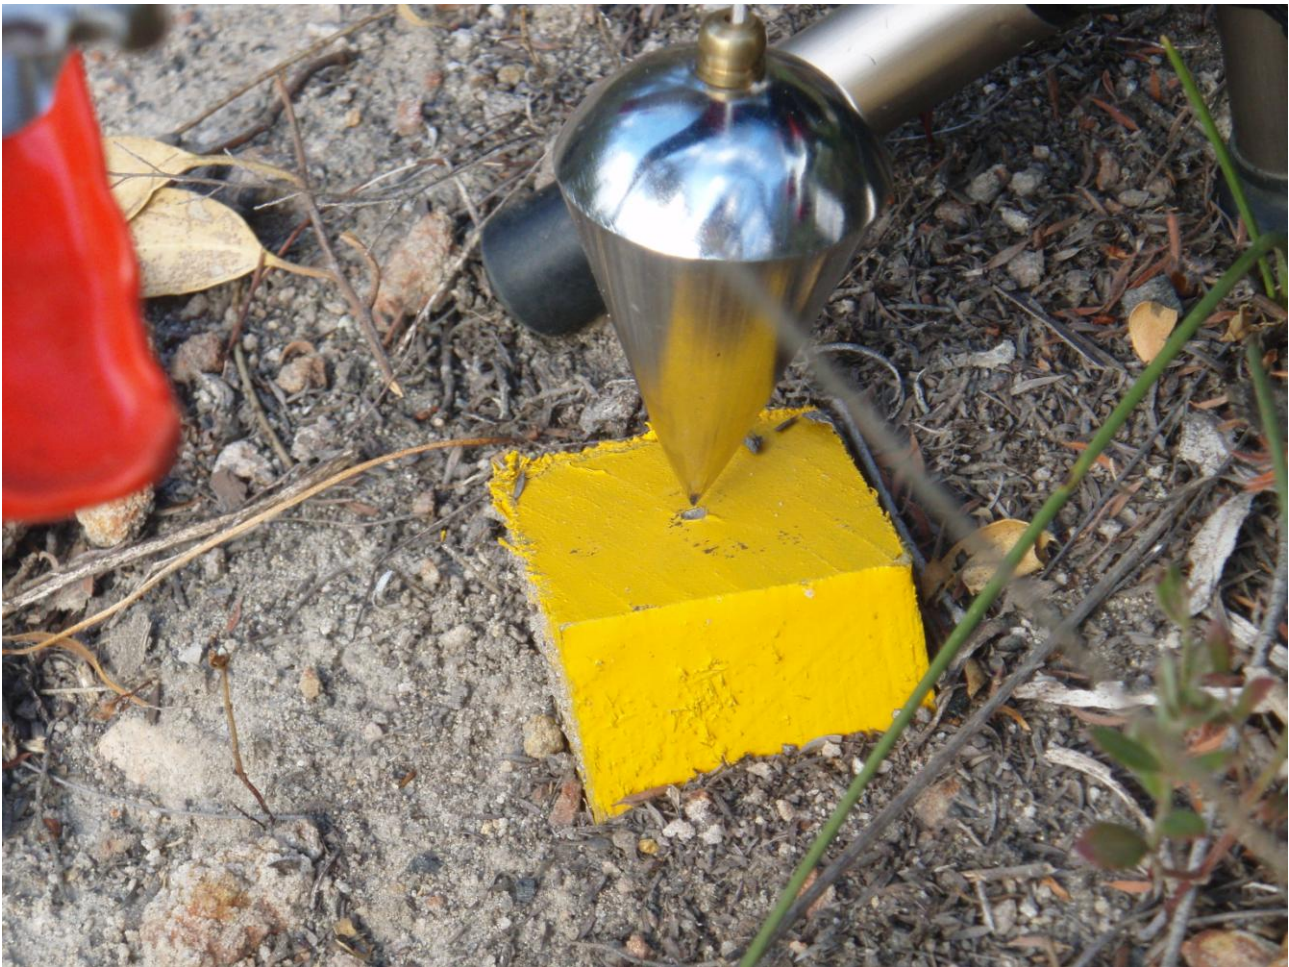
A close-up view of how the plumb bob is positioned over a reference peg is shown in Figure 6. The accuracy can be affected by wind, the stability of the tripod holding the horizontal bar and of course the ability of the operator to adjudge the required position of the plumb bob with respect to the reference peg. Note the small hole drilled into the top of the reference peg to improve the consistency of positioning. When taking the measurements and placing the tripods in particular, care is taken to disturb the vegetation and land forms as little as possible.

**Figure 6 Positioning the plumb bob over a reference peg (TV-6 March 2009)**

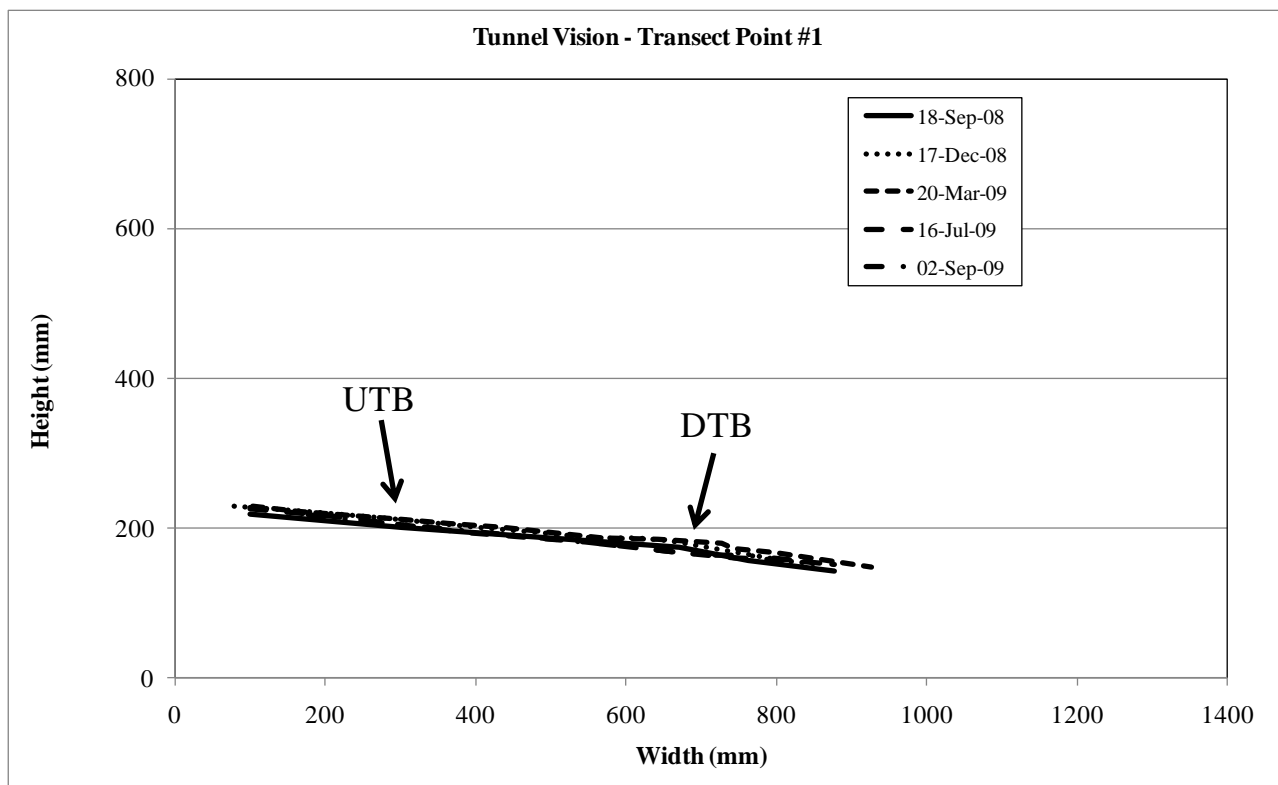
**Figure 7 Example profile graph of a transect point exhibiting no change in cross-sectional areas over the study period**

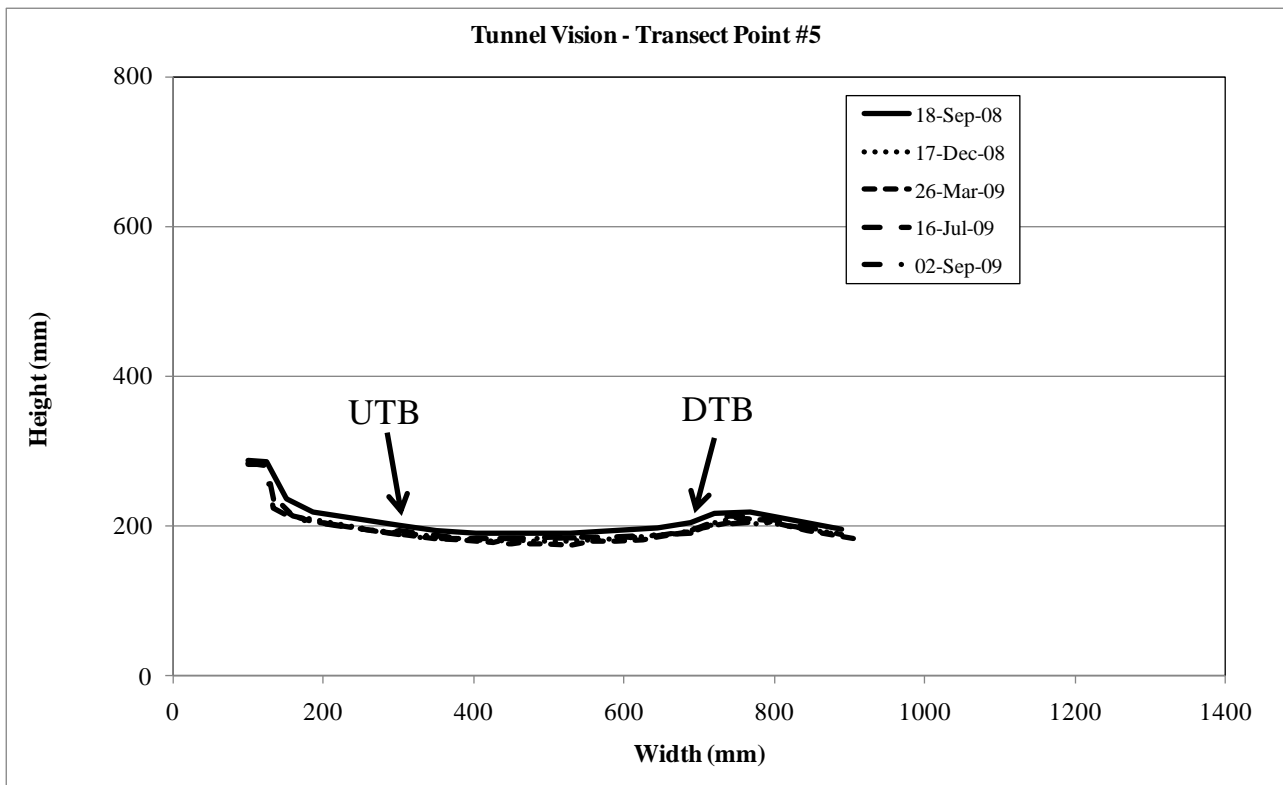
An example of this vertical shift due to measurement error in the URP of the baseline survey is given in Figure 8 where it could appear that the entire width of the trail is wearing and eroding at a remarkably similar rate. This is unlikely to occur and is not the case here. The mean change in used tread width profile area values associated with transect point #5 on *Tunnel Vision* when Survey #1 is compared with the four later surveys are: -1.0, -1.3, -0.7 and -0.8 cm<sup>2</sup>/cm respectively. If the measurement for the height of the URP is in error by 9mm in the first survey then the four compared values become: -0.1, -0.4, 0.2, and 0.1 cm<sup>2</sup>/cm and the subsequent graph is more akin to that of Figure 7 describing transect point #1 ((ie the vertical displacement between each profile line on the graph is much smaller than in Figure 8). Hence where the profiles have very similar shape but are vertically displaced, the profiles are described as ‘consistent’.

**Figure 8 Example of a consistent set of transect profiles**

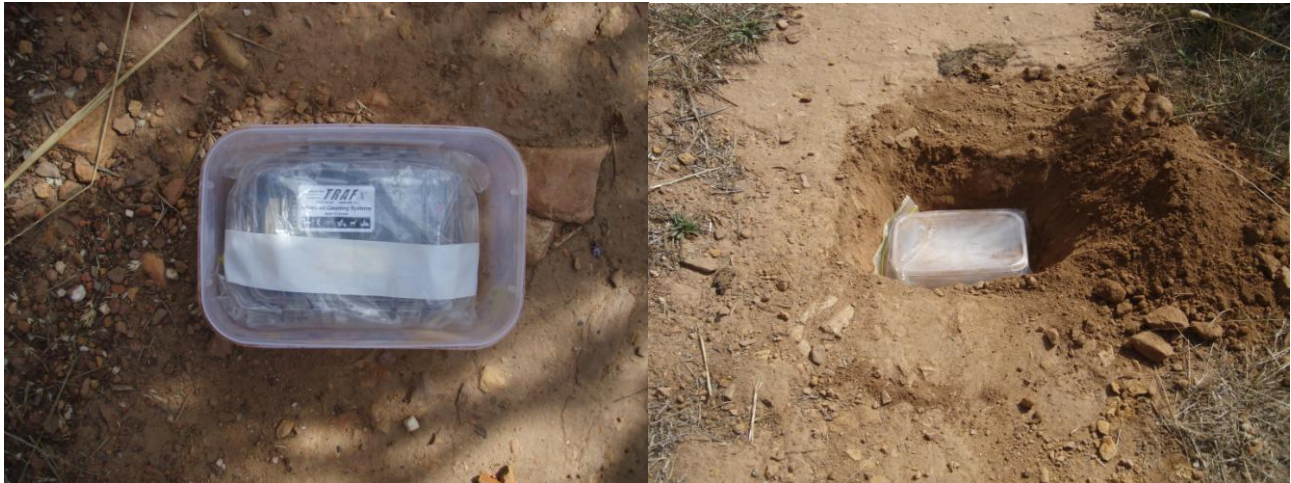
The dates of deployment and data retrieval are shown in Table 2. Figure 10 shows one of the counters being deployed at *Dynamic Tension* in March 2009. Note the several levels of sealed plastic protection necessary to prevent water affecting the electronics of the counter.

**Figure 10** TRAFx mountain bike counter deployment (*Dynamic Tension*, March 2009)

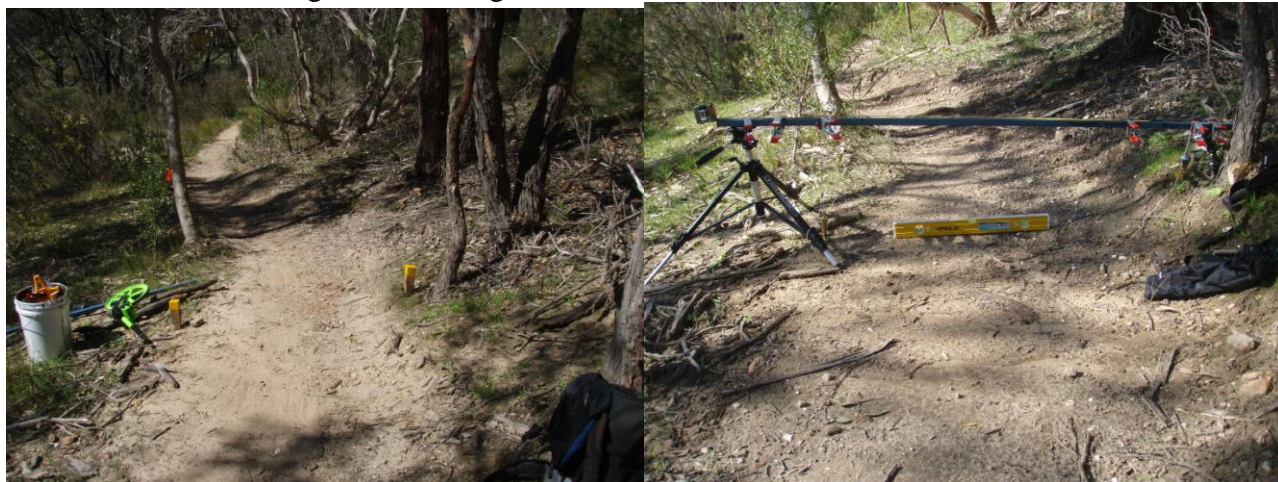
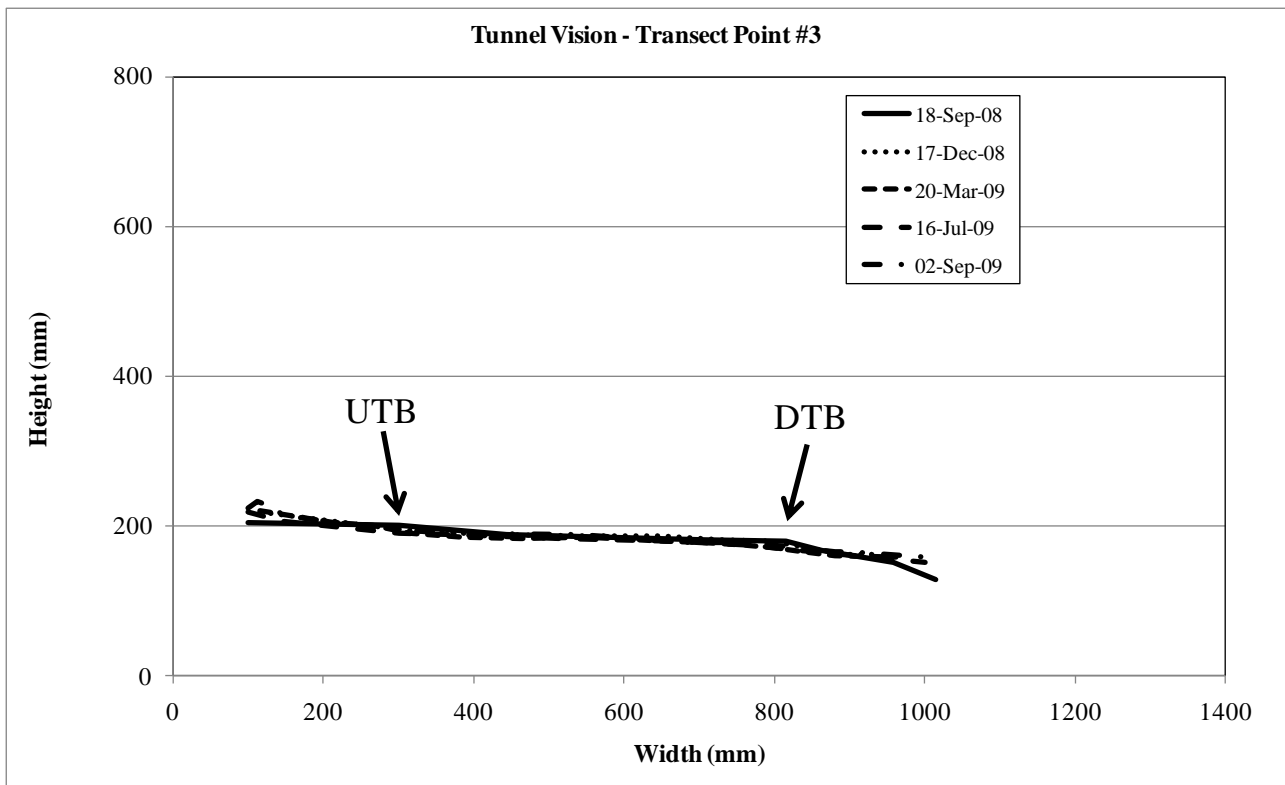
This transect point is on the exit of a downhill s-bend. The values of the mean change in profile area are within the variation to be expected from the measuring technique. There is some evidence of a small amount of soil movement from the upside bench across the trail at the transect point: the tread has outslope. There are no channels from erosion or tyres. The surface is hard soil with some embedded small stones. The used tread has narrowed over the year. The transect point is on a slope of about 8 per cent and has the near-optimum trail to fall line angle of  $85^\circ$ .

Conclusion: minor, insignificant change.

**Figure 11 Two views of TV-3: September 2008 and September 2009. NB these two photos were taken in slightly different places and at different heights.**

**Figure 12 TV-3 transect profile changes showing minor but insignificant changes on the downslope side**

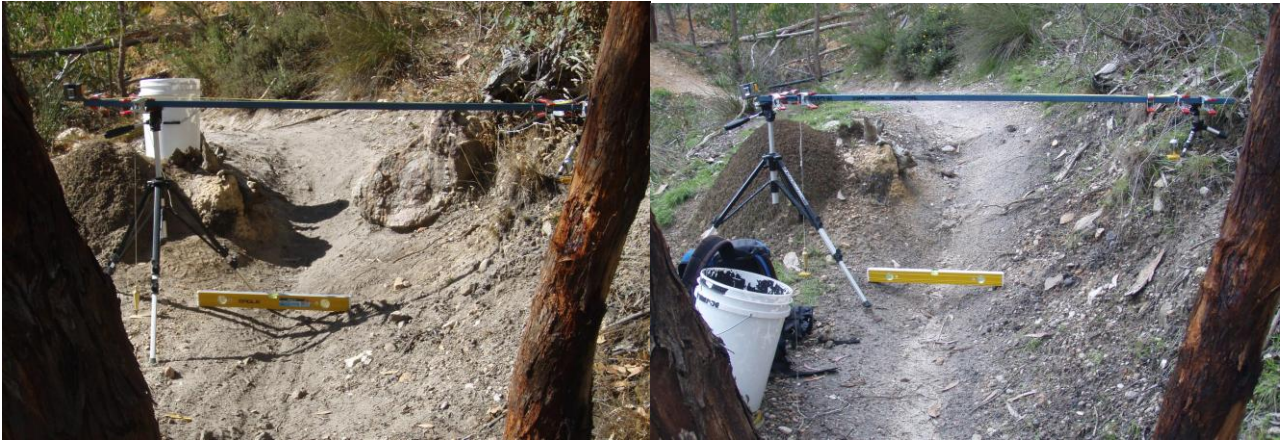
The alteration to the trail adjacent to the transect point was to remove the rock and hence widen the trail. The transect profiles over the surveys of March, July and September 2009 showed a compression or loss of soil consistent with the surface bedding in and the profile is still concave. The used tread width did not change over this period and the mean changes in profile area tend to indicate the tread has little more bedding in to do. The trail to fall line angle is 90°. The approach to the transect point for a rider is the same as before. The approach to the transect point is still uphill and between the two trees.

Conclusion: minor change due to the tread bedding in after alterations (see Figure 15).

**Figure 13** TV-8 before (March 2009) and after (September 2009) the removal of the rock and the reshaping work of 26 March 2009

**Figure 14** TV-8 before the reshaping work on 26 March 2009

**Figure 15 TV-8 after the reshaping work of 26 March 2009**

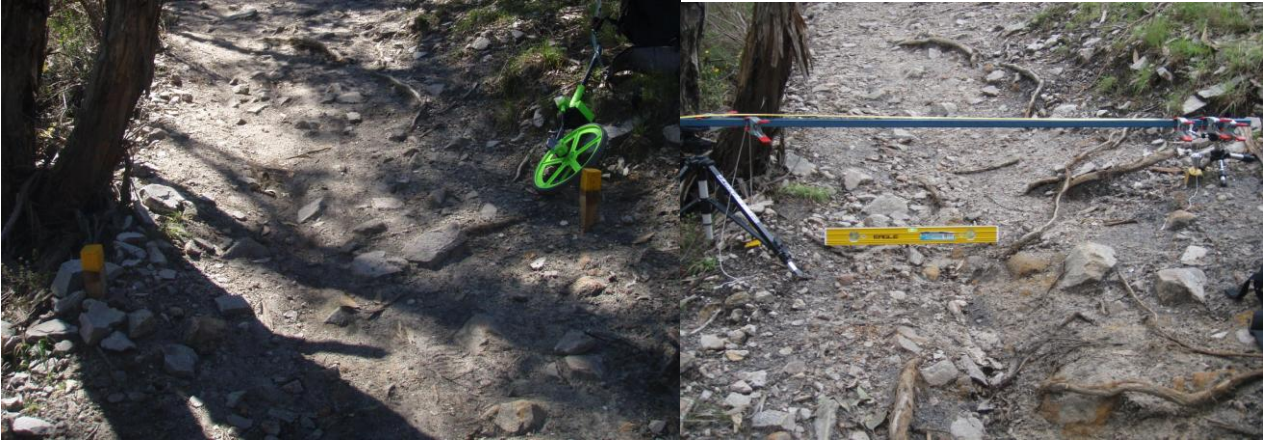
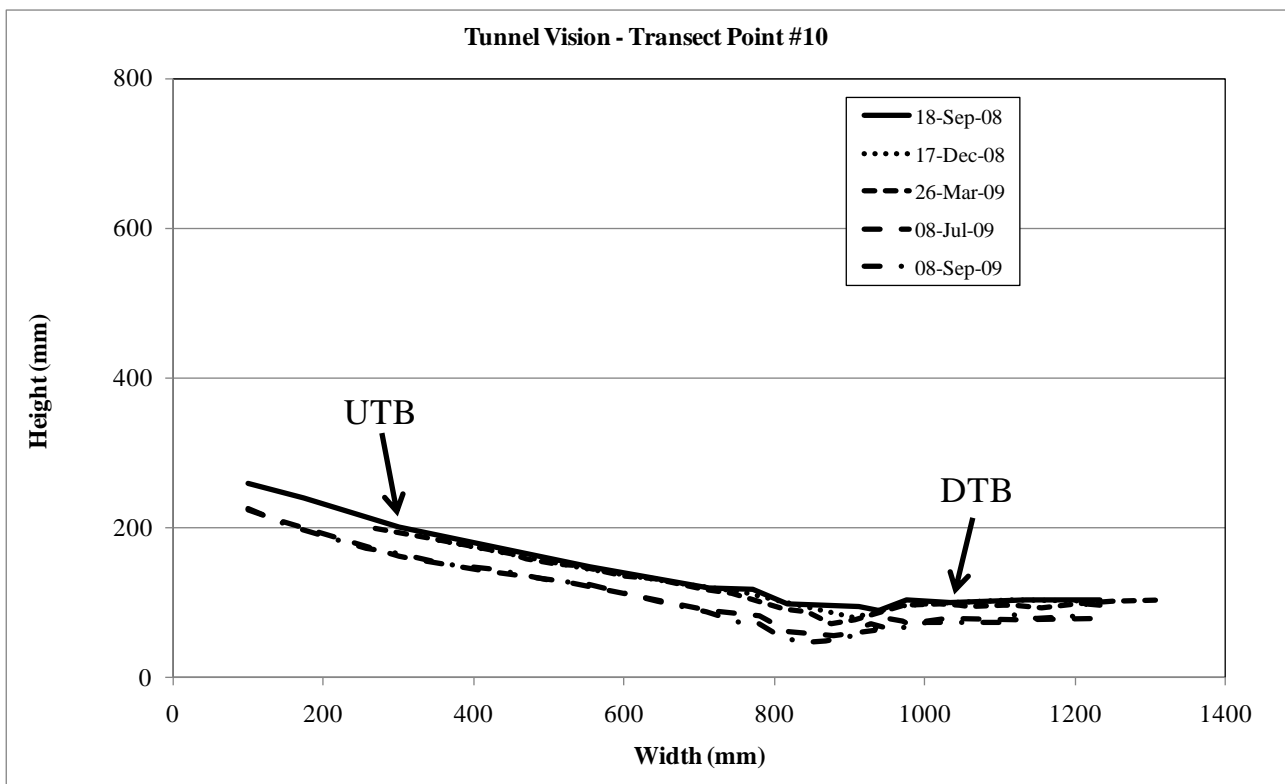
per day which is within the range of the estimate of 25 to 30 per day for the whole year – excluding event traffic – and is about 18 per cent of the total) with no change from July to the September survey. The soil loss across the transect for a nominal 1 cm wide strip could easily fit onto a small garden trowel and there was no evidence of deep gouging (Figure 16).

Conclusion: significant change (loss).

Figure 16 TV-10 in September 2008 and September 2009 showing the effects of soil movement

Figure 17 TV-10 profiles

some soil loss between the March and July 2009 surveys when 47 per cent of the rainfall of the study period and about 18 per cent of usage occurred. There was no discernible change from the July survey to the September survey. The recommended technique of rock armouring would significantly increase the sustainability of this portion of trail.

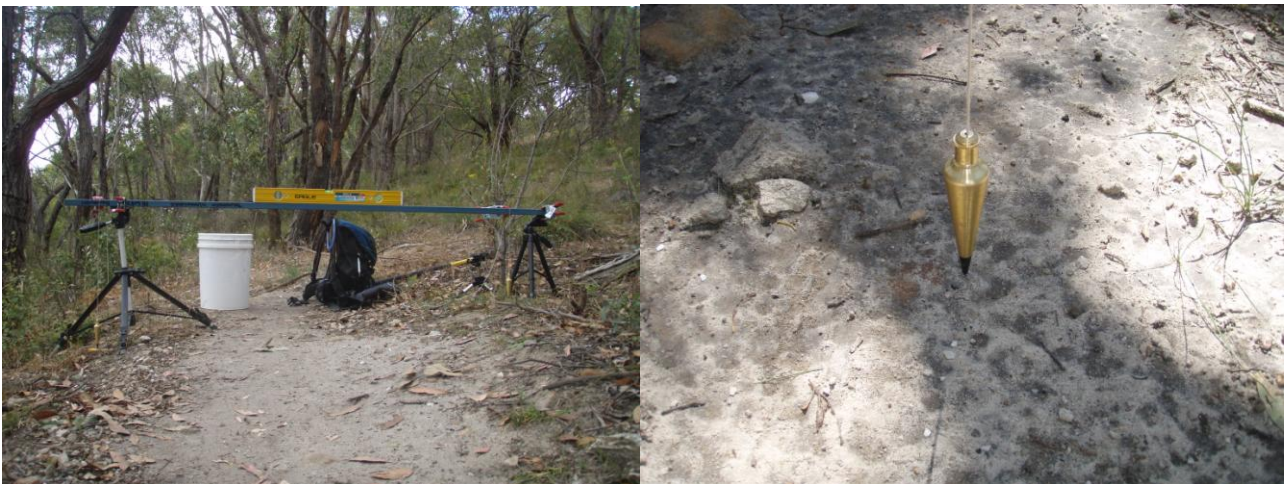
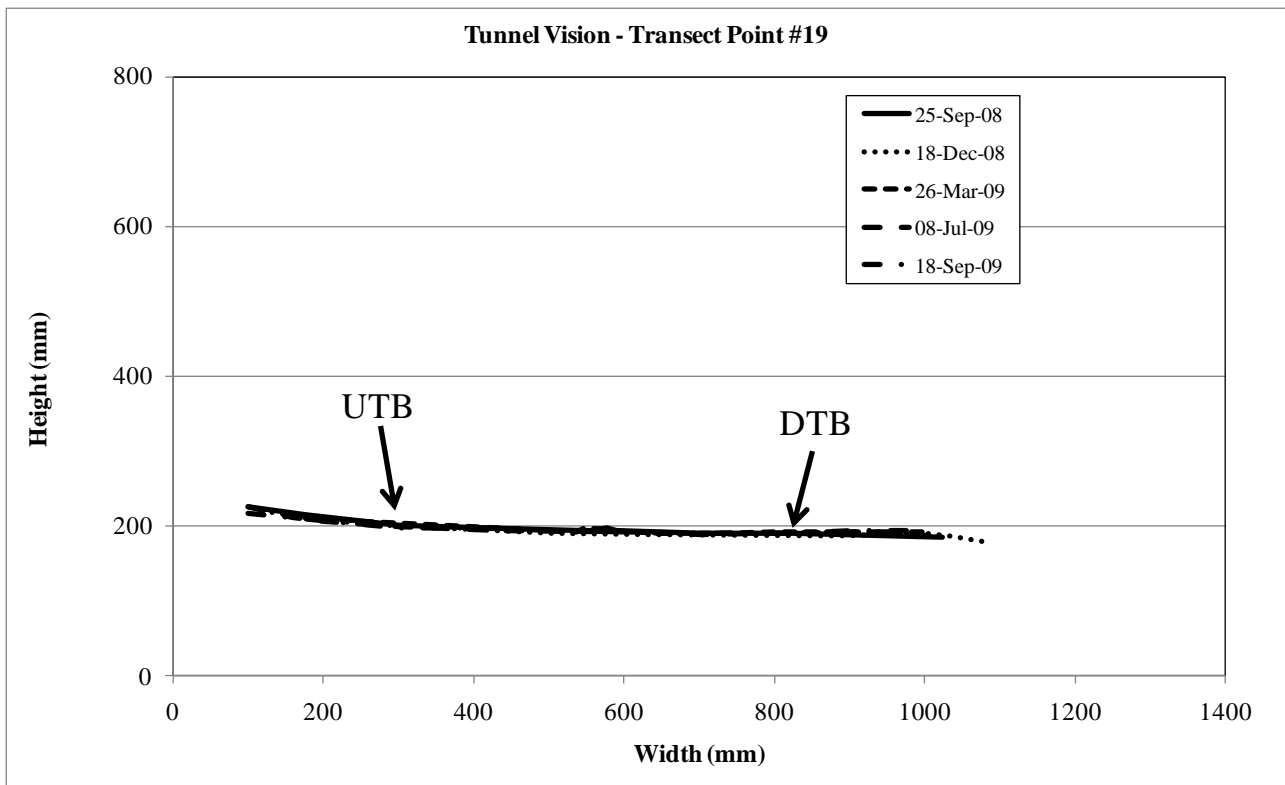
This transect point is on the edge of a plateau between two slight rises. The trail gradient to the transect point is about seven per cent and away about 2 per cent for about three metres before a climbing turn. The surface is soil with leaf litter and small twigs (Figure 18). The transect profiles are consistent (Figure 19), nearly straight and the tread has outslope. The used tread width has not changed. The trail to fall line angle is 80°. The mean change values are minimal.

Conclusion: no change.

**Figure 18 TV-19 in September 2008 and the surface in September 2009**

**Figure 19 TV-19 profiles**

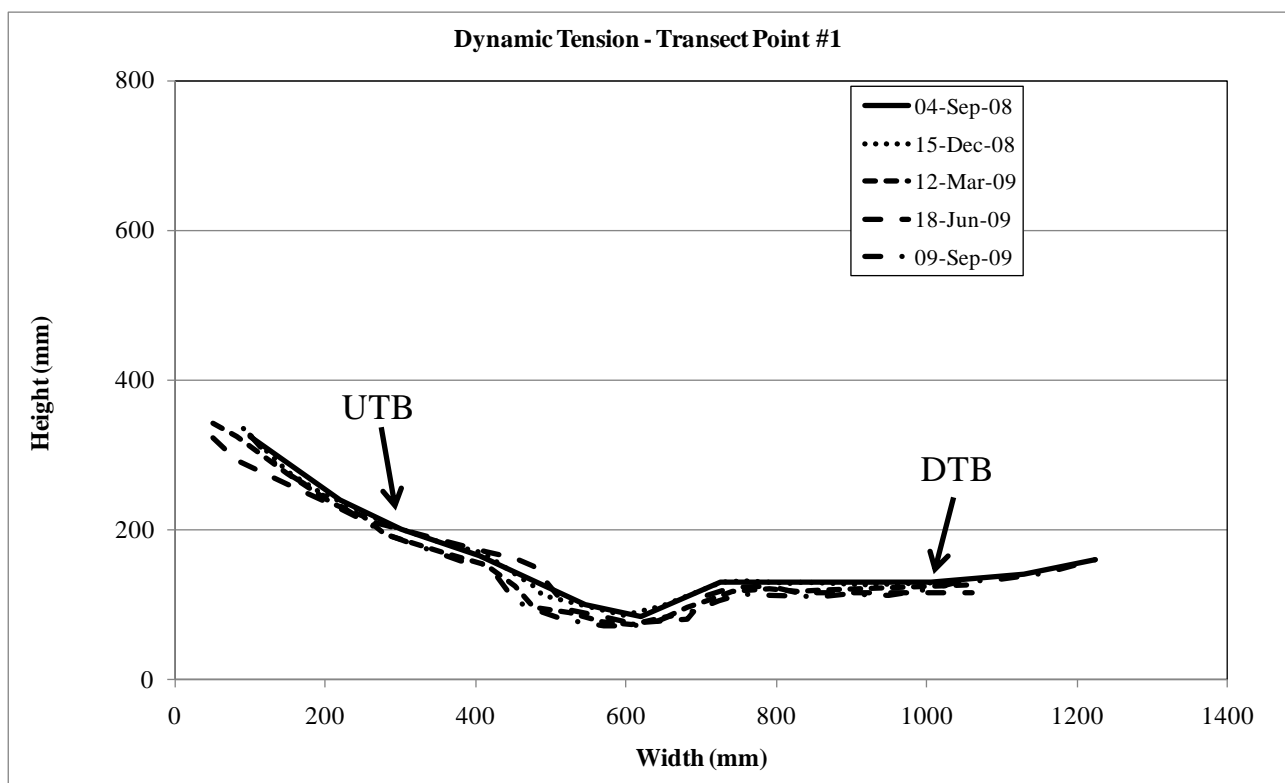
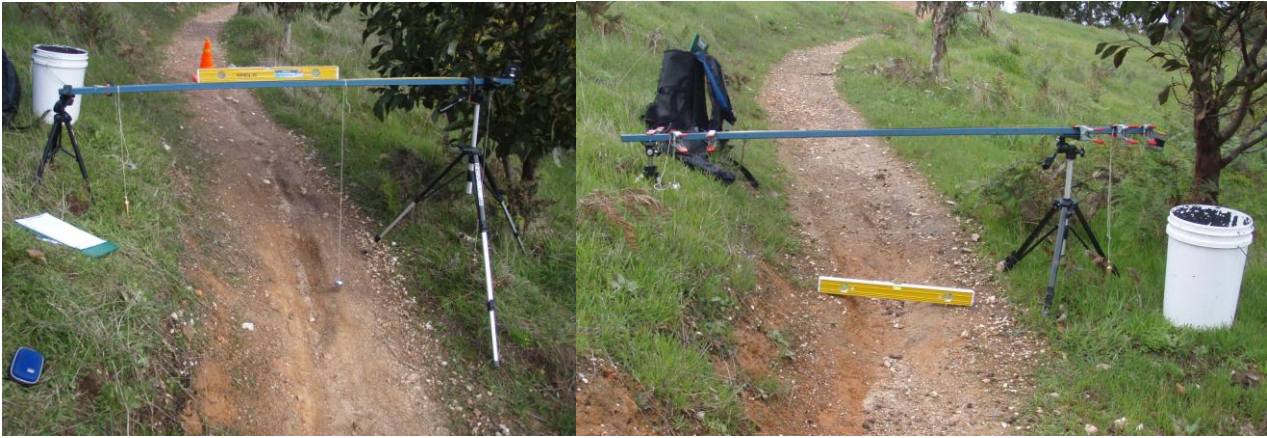
The trail to fall line angle is small at about 55° and the distance to the grade reversal when climbing on the trail away from the transect point (the uptrail grade reversal) is about 8 metres. At the first survey in September 2008 there was a noticeable channel where soil loss from the used tread had occurred (Figure 20). This deepened and widened slightly between September and December 2008 during which time the trail experienced about 12 per cent of the rainfall and its mean use per day was 10 to 11 riders or about 22 per cent of total estimated use.

The channel further deepened and widened by March 2009 during which time the trail experienced approximately 9 per cent of rainfall and about 9 riders per day (about 16 per cent of total use). After experiencing some soil loss in the first half of the study the transect point profile now appears to be stable. There was no discernible change in the profile between March and June 2009. This period included the *Dirty Weekend* event when about 51 per cent of the usage for the study year occurred.

Figure 20 DT-1 transect profiles

**Figure 21** *Dynamic Tension* transect point #1 in September 2008 and September 2009 showing the widening of the riding channel

Conclusion: significant change (loss).

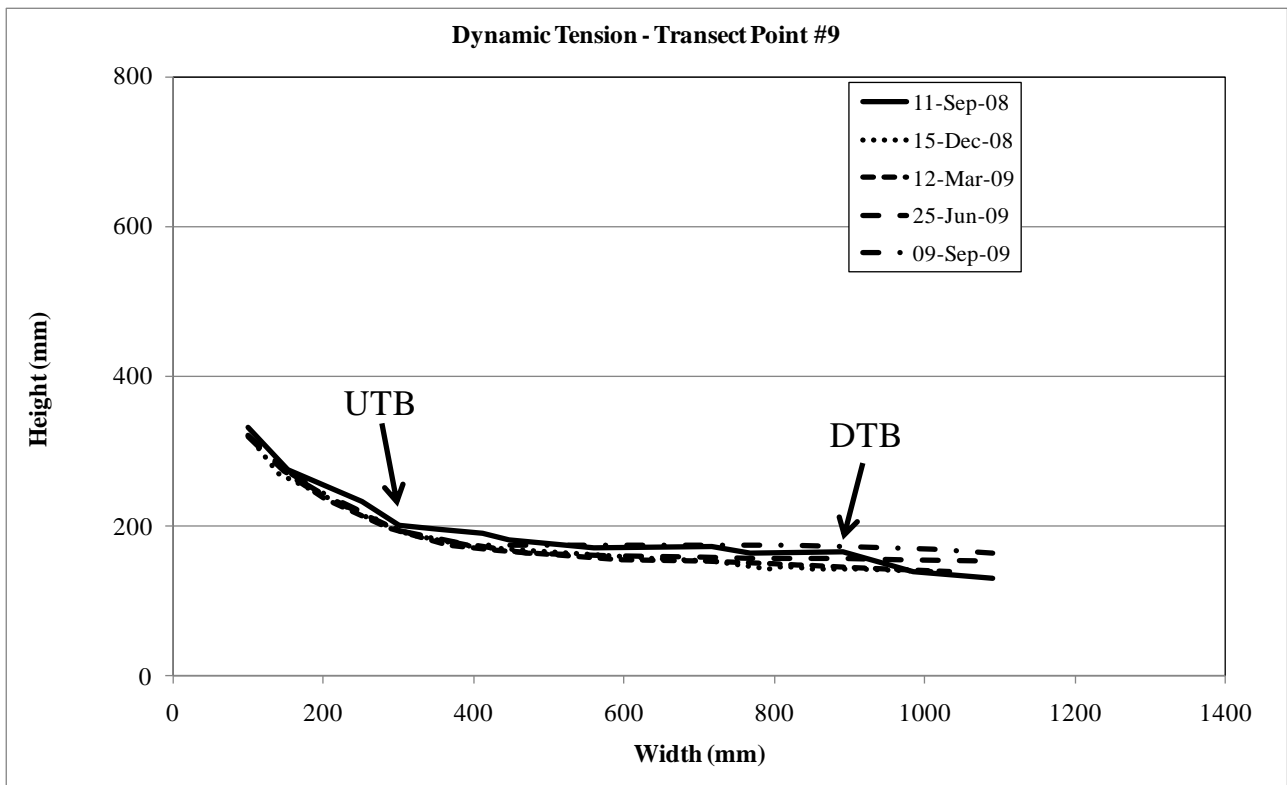
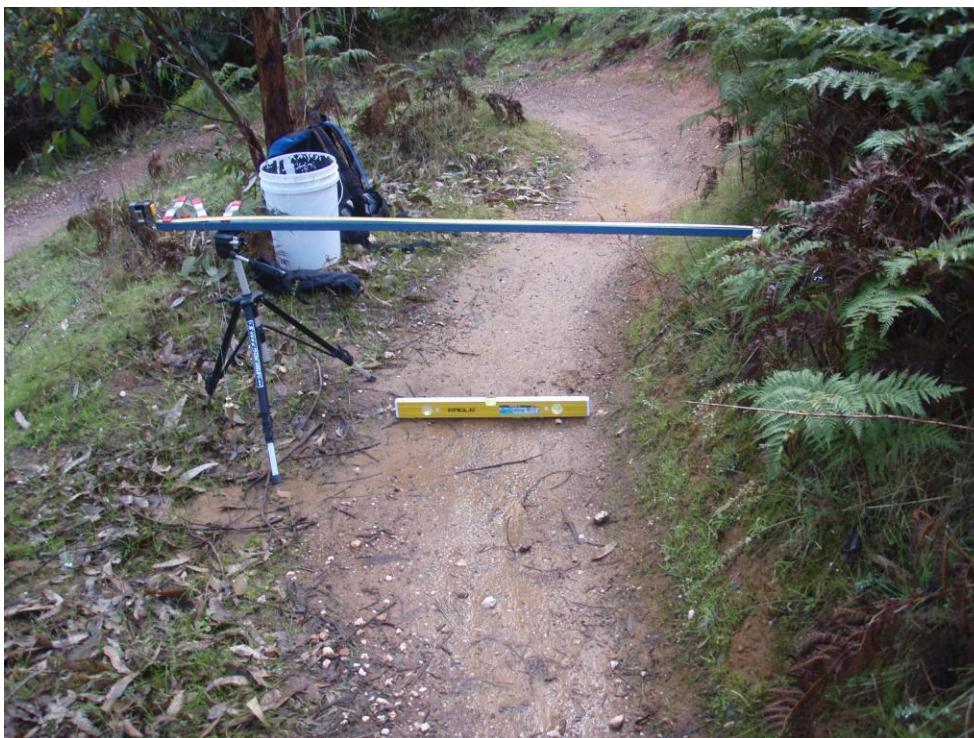
Transect point #9 is the other point that revealed significant change over the course of the study: it exhibited both soil loss and gain. The point is at the foot of a descending, right-hand curve of the trail and is at a drainage point on the turn that leads several metres away into a left-hand descending turn. The trail at the transect point has gradients of 1 and 4 per cent either side. The mean change values and the transect profile graphs indicate soil loss from September to December 2008 (about 12 per cent of rainfall and about 22 per cent of riders over this period) then deposition from June to September 2009 (40 per cent of the rainfall occurred in this period and about 12 per cent of riders) (see Figure 22 for transect profiles and Figure 23 for a snapshot taken in June 2009). These changes resulted in a nett zero change in transect profile area over the study period. The surface is soil with embedded small stones that help secure the soil. The used tread width has not changed and the tread started with slight outslope and is now almost flat from sediment deposition at the drain point. The trail to fall line angle is about 60° and the long side uptrail grade reversal distance is 17 m (in this case towards the start of the trail). The shape of the tread for about 10 m on the uptrail side is

concave and this, coupled with the low trail to fall line angle would not allow water to run off the trail but induce it to move down to the transect point. The profile measurements, backed by the photographic record and notes taken during the study show that this water does carry some sediment that is deposited at the drain at the transect point.

Figure 22 DT-9 profiles

Figure 23 *Dynamic Tension* transect point #9 in June 2009

Conclusion: significant change (loss and gain).

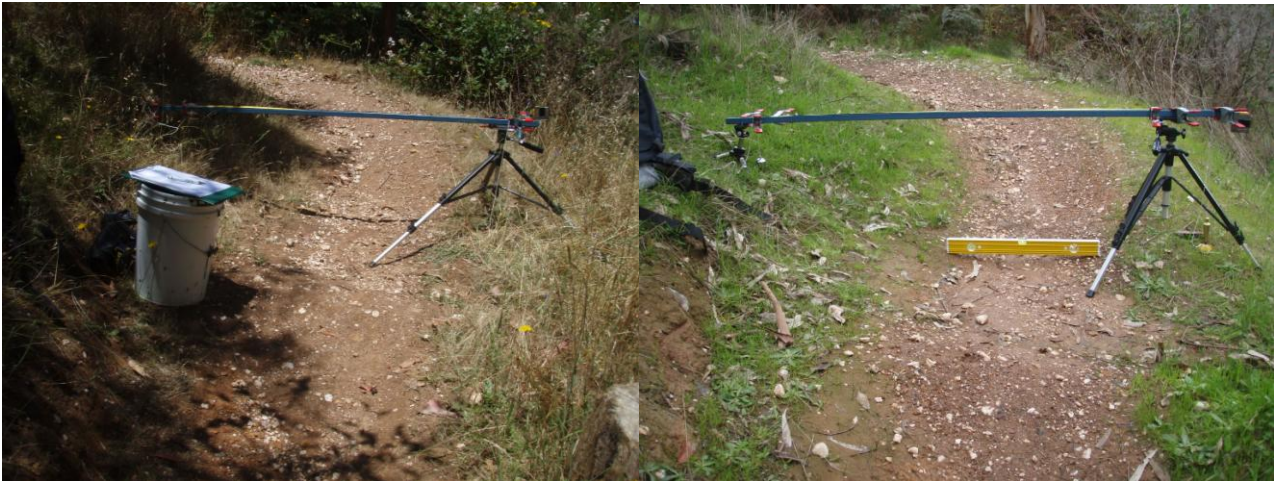
This transect point is at the exit of a right-hand descending turn about one metre before a trail drainage point which is just before a left-hand turn. The gradient is quite steep at 12 per cent for 2 metres of the 10 m to the uptrail grade reversal. The surface is hard soil with many small stones; some embedded and some loose (Figure 24). The mean change values and graphs (Figure 25) indicate some soil loss between September and December 2008 and possibly more loss between March and June 2009. The tread is concave and the used tread width has narrowed by 18 per cent. The trail to fall line angle is 75°.

Conclusion: minor, insignificant change (loss).

Figure 24 DT-10 in December 2008 and September 2009

Figure 25 DT-10 profiles showing the soil loss between September and December 2008

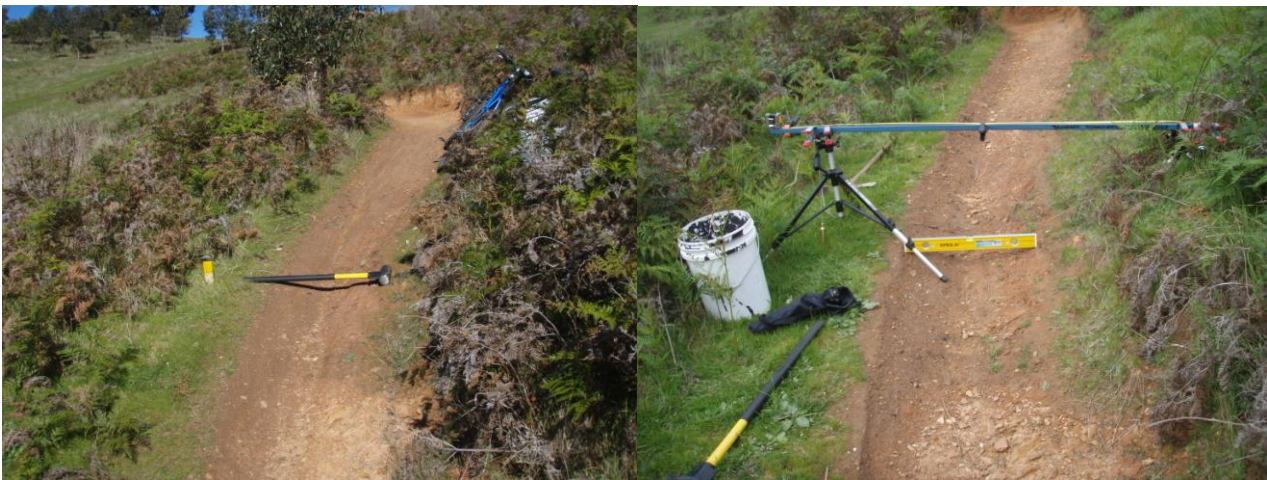
This transect point is on a part of the trail that is a descending left-hand curve with a relatively steep gradient of 20 per cent. The trail to fall line angle is 14° and it is clear that considerable wear and erosion occurred before this study commenced (see Figure 26 for a visual indication). Perhaps unexpectedly, over the course of the study little change occurred (profiles are reasonably consistent – see Figure 27 – and the mean change values are within expected variation) indicating the trail at this transect point is holding up to wear and weather. The distance to the uptrail grade reversal is 9 metres. The surface is packed soil with embedded and loose small stones. The tread at this transect point is the most concave of the *Dynamic Tension* points. The used tread width has not changed.

Conclusion: no change.

**Figure 26 DT-17 in August 2008 and September 2009 showing no change despite the minimal trail to fall line angle. Note the concave tread profile**

**Figure 27 DT-17 profiles**
